State of Nevada
Department of Health & Human Services
Division of Mental Health & Development Services
Desert Regional Center
Facility Condition Analysis

DESERT REGIONAL CENTER

1391 South Jones Blvd.
Las Vegas, Nevada 89146

Site Number: 9993
STATE OF NEVADA PUBLIC WORKS DIVISION
FACILITY CONDITION ANALYSIS

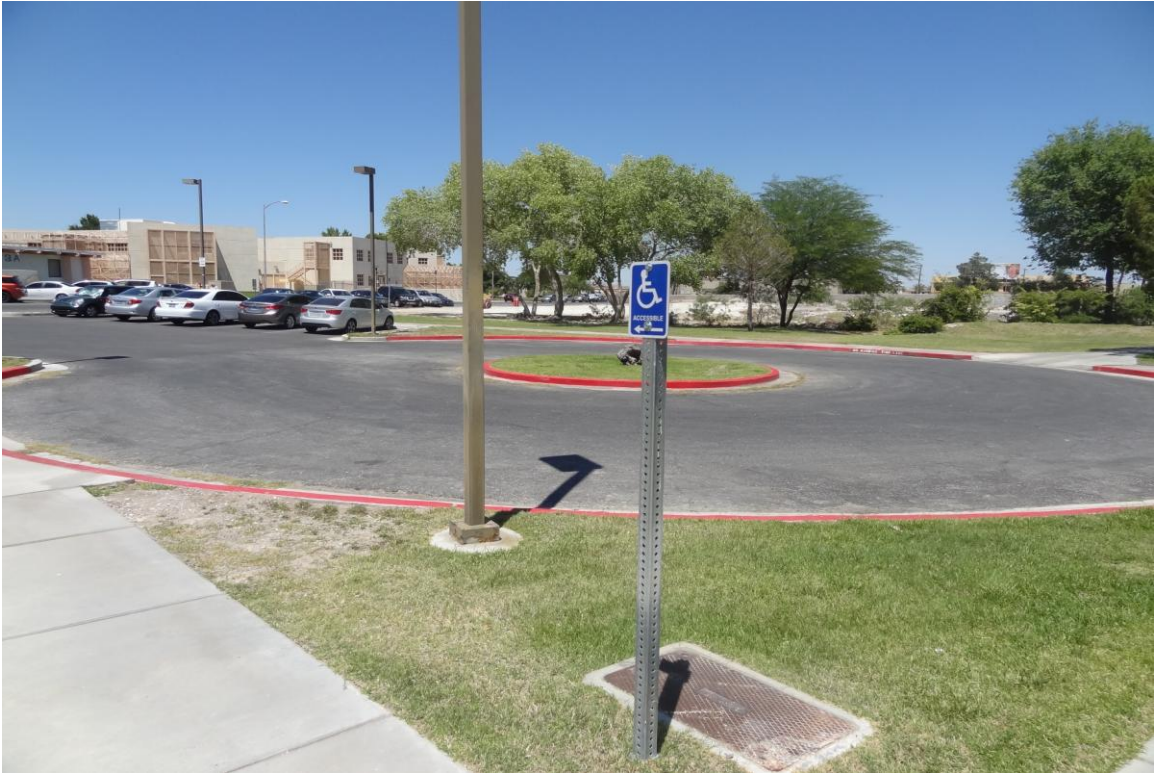
Desert Regional Center Site – FCA Site #9993
Description: Circular drive by building #1300 prone to flooding.

There are numerous places where drainage ponding occurs on Transverse Drive. The entire roadway should be removed and replaced, and a sidewalk with curb and gutter should be installed along the north side of Transverse Drive, after grading occurs to achieve proper drainage. This project provides for removal and replacement of the asphalt paving and concrete sidewalks. 40,000 square feet of roadway and sidewalks was used to generate the estimate.
